Rehabilitation of Kidatu Power Plant Project Presentation

Rehabilitation of Kidatu Power Plant

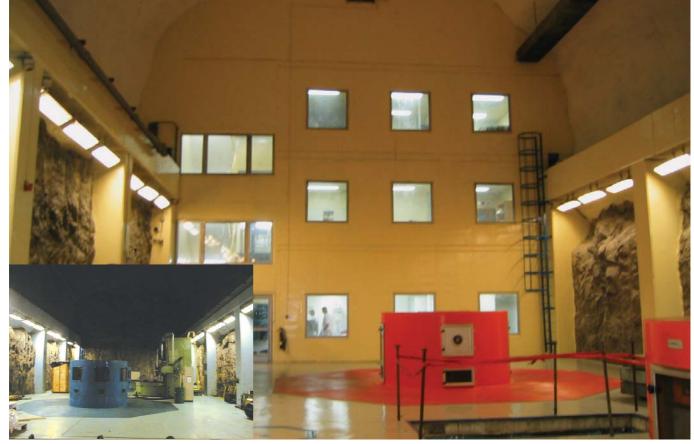
Machine hall before and after rehabilitation

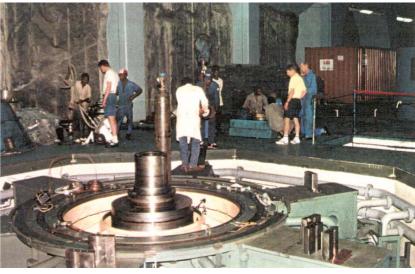
Generator under rehabilitation

As recommended in the feasibility study, it was agreed to modify the bearings to avoid overheating and oil leakages by introducing additional sealings. It was also agreed to modify the ventilation of the slip-ring housing with a different and new arrangement, which meant a complete reconstruction of the slip-ring housings.

During the modifications the rotor was removed and completely cleaned

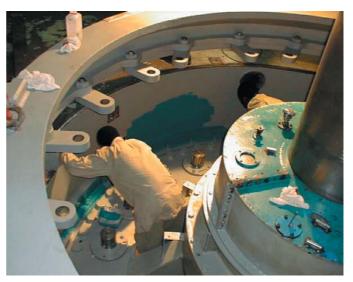
Rehabilitation of turbine 2

Almost all the blades of the turbine runners I and 2 had severe cavitation both on the inlet and suction side. Some of these damages were as large as 300 by 100 mm and almost 20 mm deep. When grinding, some of the cavities proved to be almost through the blade. Consequently, it became difficult to repair with a good and lasting result.

The runners were grinded and weld-repaired at the Kidatu, and new facing plates were fitted.
